Use of implant testing to evaluate the  
susceptibility of HY-130 steel weldments to  
hydrogen embrittlement.

USE OF IMPLANT TESTING TO EVALUATE  
THE SUSCEPTIBILITY OF HY-130 STEEL  
WELDMENTS TO HYDROGEN EMBRITTLEMENT

Bradley J. Mason

December 1981

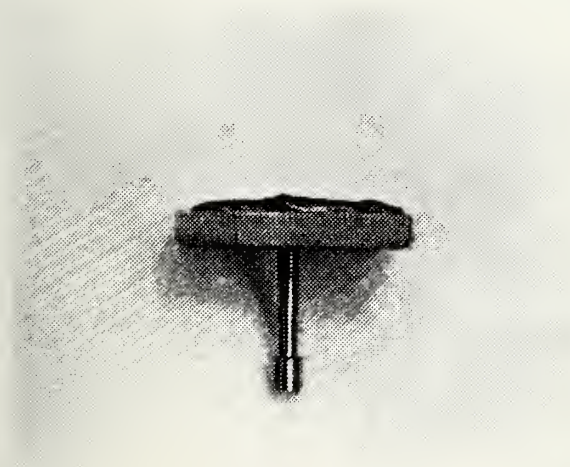
6c) Welded Implant Assembly

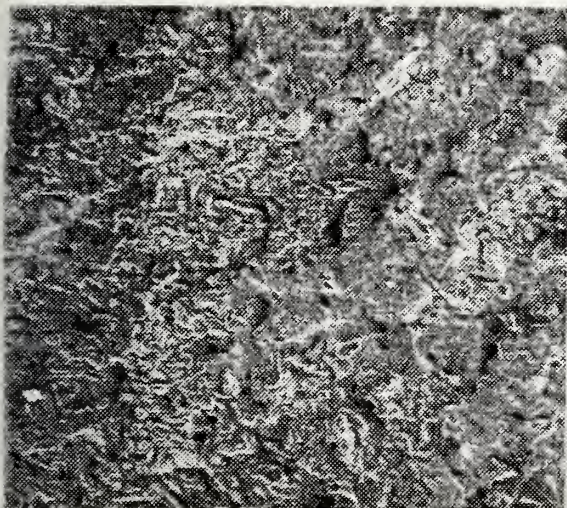
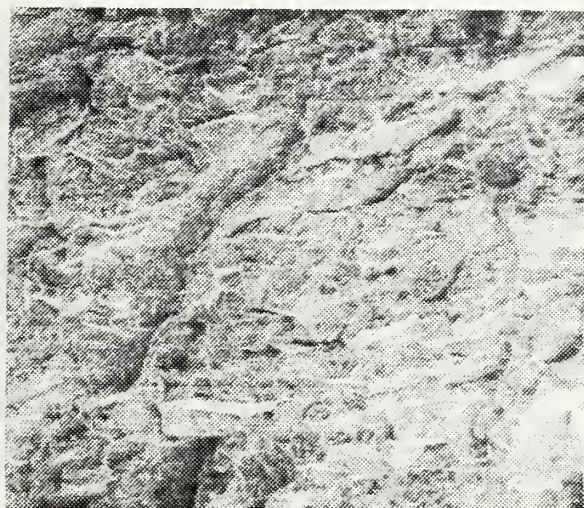
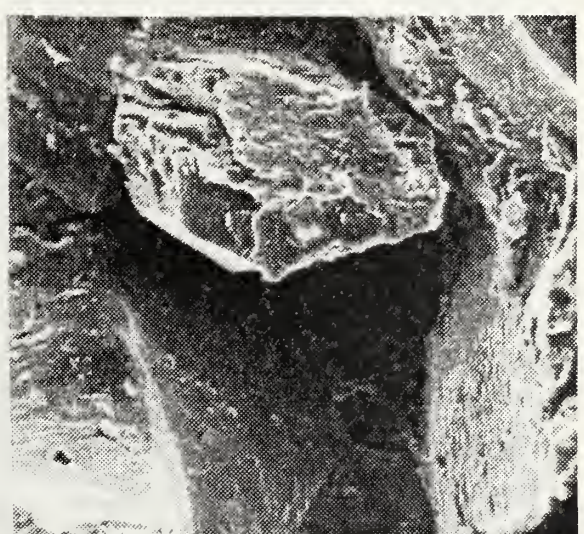
a) 50X, 2.4 ppm H<sub>2</sub>, (70% Ductile)

b) 50X, 20.2 ppm H<sub>2</sub>, (10% Ductile)

c) 500X - Dimpled Fracture

d) 500X - Dimpled Fracture

e) 500X - I.G. Fracture

f) 500X - I.G. Fracture

Figure 23. Plate 2, Short Transverse Direction, Normal (Left) and Enhanced Hydrogen (Right) Welding Conditions

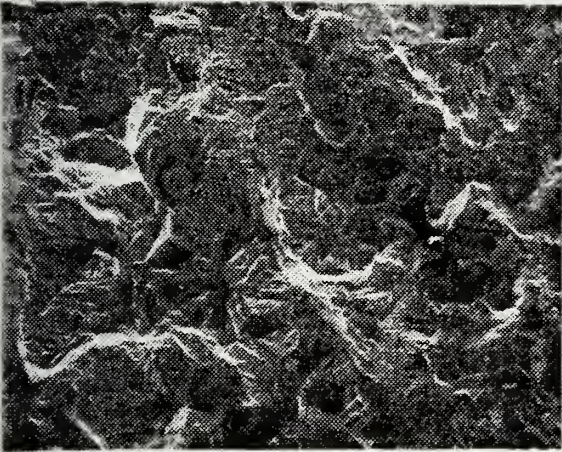
a) 50X, 1.1 ppm  $H_2$ , (70% Ductile)

b) 50X, 19.4 ppm  $H_2$ , (30% Ductile)

c) 500X - Dimpled Fracture

d) 500X - Dimpled Fracture

e) 500X - I.G. Fracture

f) 500X - I.G. Fracture

Figure 24. Plate 2, Longitudinal Direction, Normal (Left) and Enhanced Hydrogen (Right) Welding Conditions

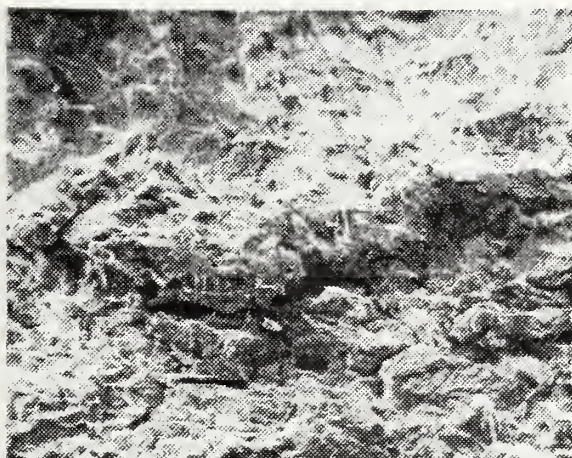
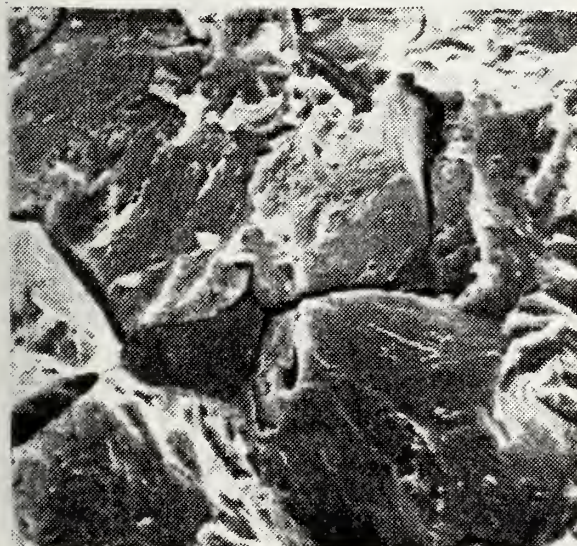
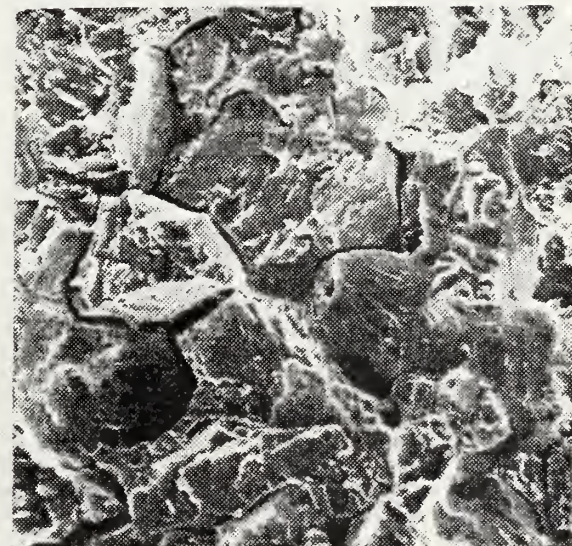
a) 50X, 1.1 ppm H<sub>2</sub>, (80% Ductile)

b) 50X, 18.3 ppm H<sub>2</sub> (25% Ductile)

c) 500X - Dimpled Fracture

d) 500X - Dimpled Fracture

e) 500X - I.G. Fracture

f) 500X - I.G. Fracture

Figure 25. Plate 4, Short Transverse Direction, Normal (Left) and Enhanced Hydrogen (Right) Welding Conditions

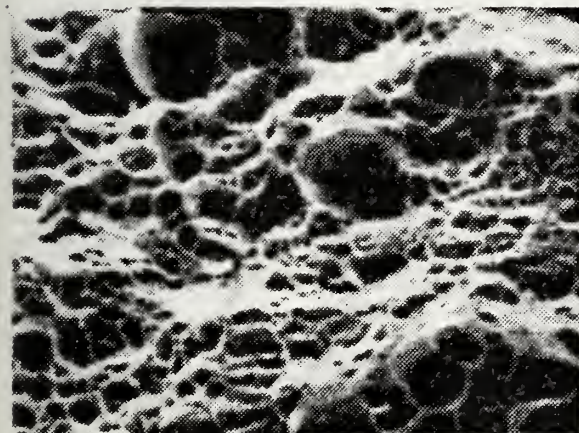
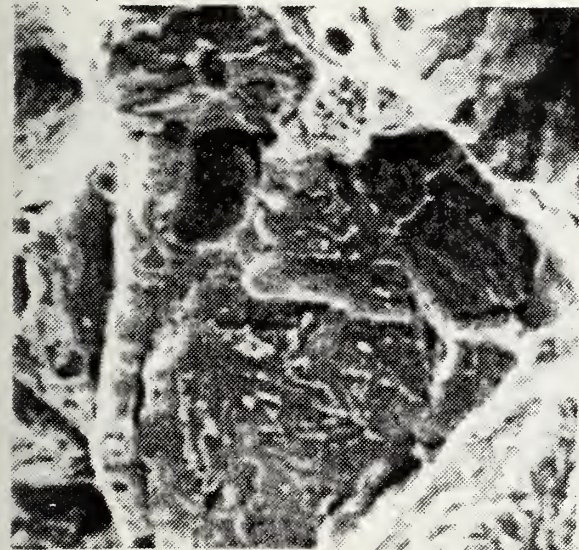
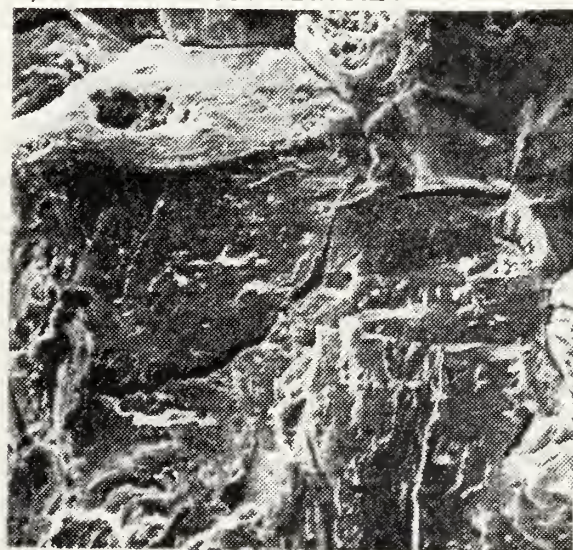
a) 50X, 4.2 ppm H<sub>2</sub> (85% Ductile)

b) 50X, 19.5 ppm H<sub>2</sub> (20% Ductile)

b) 500X - Dimpled Fracture

d) 500X - Dimpled Fracture

e) 500X - I.G. Fracture

f) 500X - I.G. Fracture

Figure 26. Plate 4 Longitudinal Direction Normal (Left) and Enhanced Hydrogen (Right) Welding Conditions

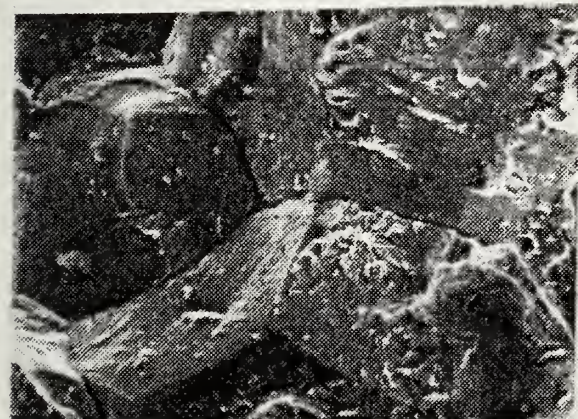
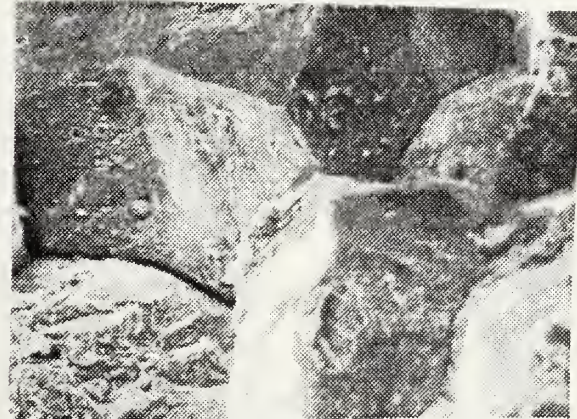
a) 50X, 0.7 ppm H<sub>2</sub> (80% Ductile)

b) 50X, 19.1 ppm H<sub>2</sub> (25% Ductile)

c) 500X - Dimpled Fracture

d) 500X - Dimpled Fracture

e) 500X - I.G. Fracture

f) 500X - I.G. Fracture

Figure 27. Plate 6, Short Transverse Direction, Normal (Left) and Enhanced Hydrogen (Right) Welding Conditions

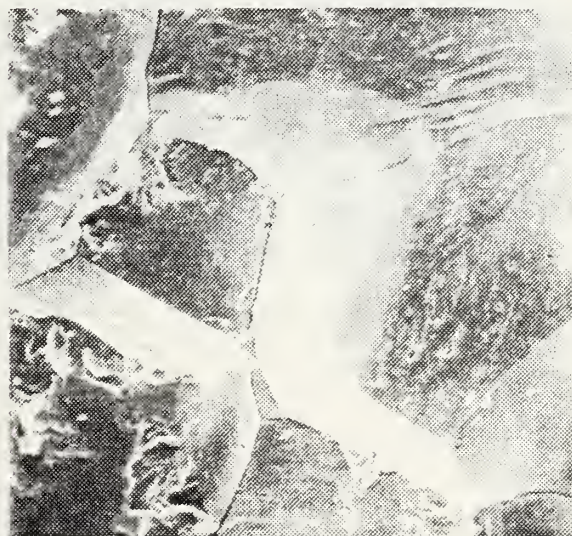
a) 50X, 1.1 ppm H<sub>2</sub> (60% Ductile)

c) 500X - Dimpled Fracture

e) 500X - I.G. Fracture

b) 50X, 14.4 ppm H<sub>2</sub> (25% Ductile)

d) 500X - Dimpled Fracture

f) 500X - I.G. Fracture

Figure 28. Plate 6, Longitudinal Direction, Normal (Left) and Enhanced Hydrogen (Right) Welding Conditions

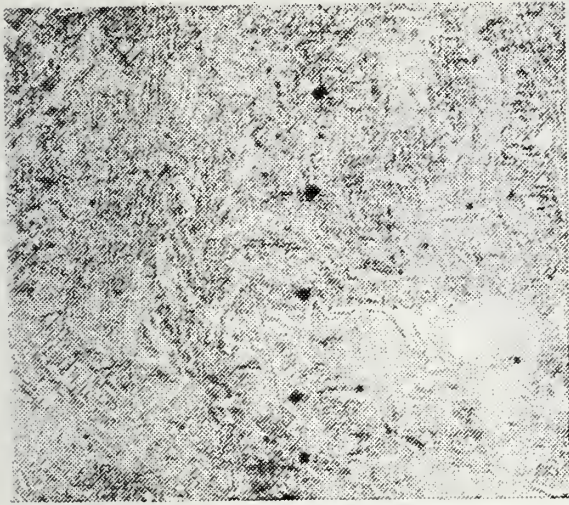
a) 64X - Weld Fusion Line

f) 450X - 1.0 mm Below Fusion Line

Figure 36. Microstructure of Cast Plate Weldment  
(Plate 6)

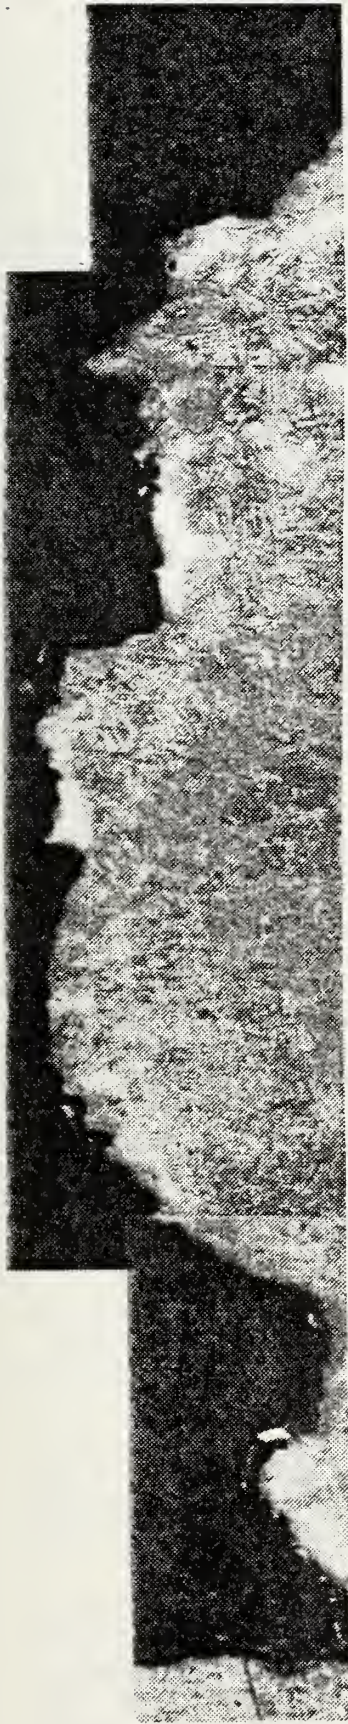
a) 64X - View of Fracture Surface, Enhanced Hydrogen Welding Conditions, 1% Nital Etch. Fracture Occurred Through Base Metal Heat-Affected Zone (Reduced 40%)

b) 64X - View of Fracture Surface, Normal Welding Conditions, 1% Nital Etch. Fracture Occurred Primarily Through the Base Metal Heat-Affected Zone (Reduced 40%)

Figure 40. Microstructure of Fractured Implant Specimens from Plate 6
